# Water Compliance Inspection Report

**Compliance Evaluation Inspection Report**

**Nu-West Industries, Inc., Rasmussen Ridge Mine  
(a subsidiary of Agrium, Inc.)  
Soda Springs, Idaho**

**Inspection date: September 25, 2014  
Report completion date: January 7, 2014**

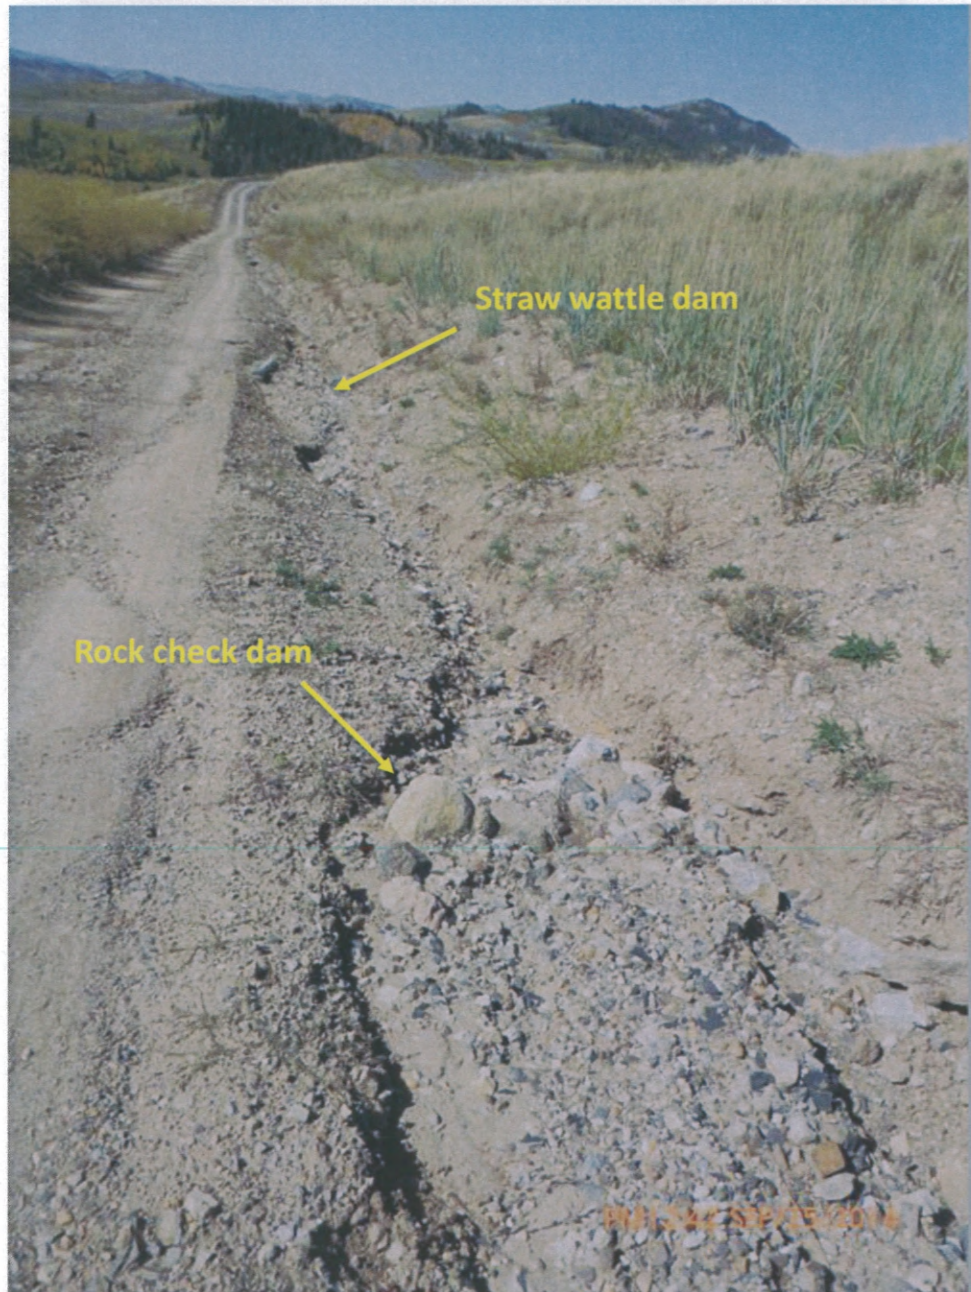
Installation of the FMTE cover system required the development of an access road to the top of the SED. From the NWRM office complex Mr. Donahoo drove us up this new access road along the northern and western side of the SED. As we drove up the road I noted that an alternating series of rock check-dams and straw wattle dams had been installed in the borrow pit along the bank-side of the dirt access road to control erosion (see Photos 10-12). I also noted, and pointed out, that most of the dams had been overtopped with sediment.

Photo No. 10 (P1000797)  
Facing north – the access road to the top of the SED exhibited extensive erosion in the borrow area on the east side of the road; check dams were overtopped with sediment.

- 2) **Maintenance of BMPs:** As described in Sections VIII and IX of this report, I noted that most of the erosion check dams (rock and wattles) located on the bank-side of the access road to the top of the SED had been overtopped with sediment (see Photos 10-12). This maintenance issue involving BMPs does not appear on any of the routine inspection reports for the mine.

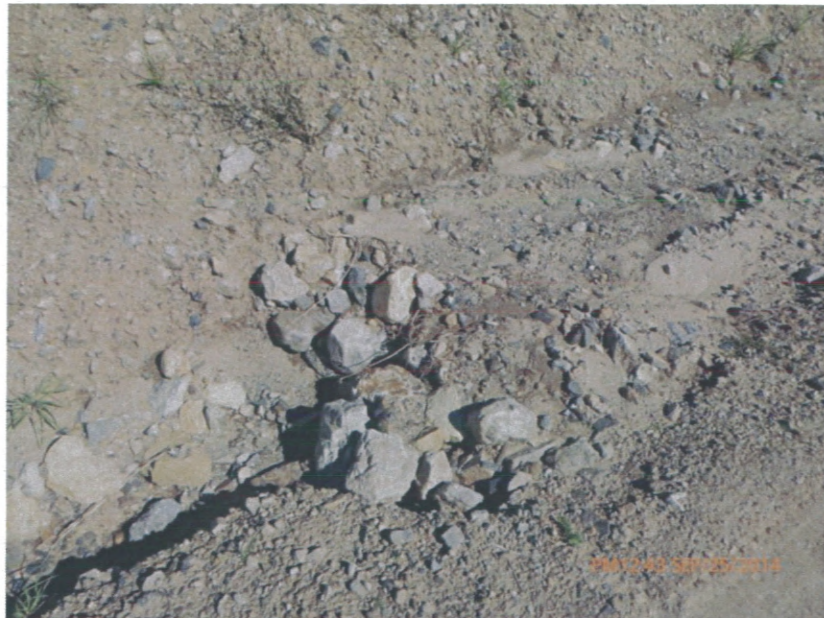
Photo No11 (P1000798)  
Overtopped rock check dam on access road to top of SED.

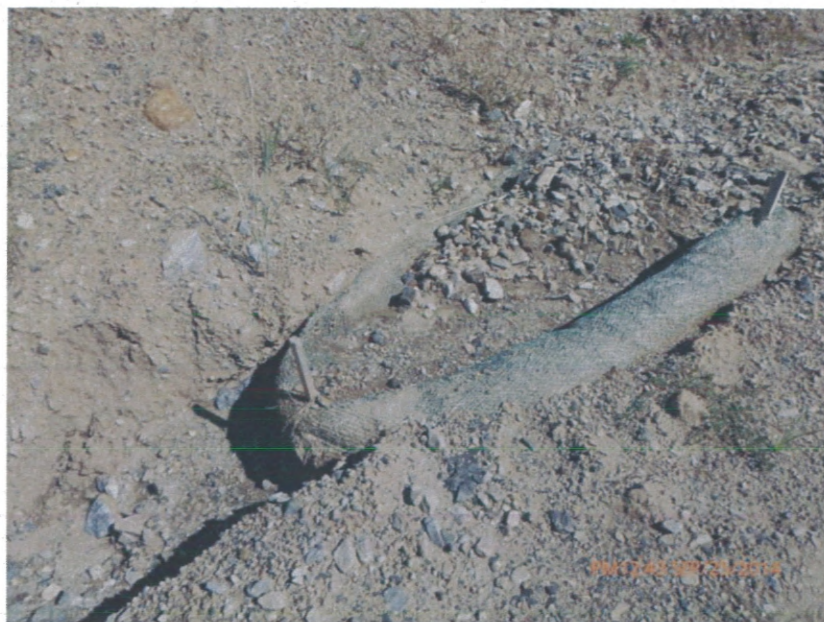
Photo No. 12 (P1000799)  
Overtopped straw wattle check dam on access road to top of SED.

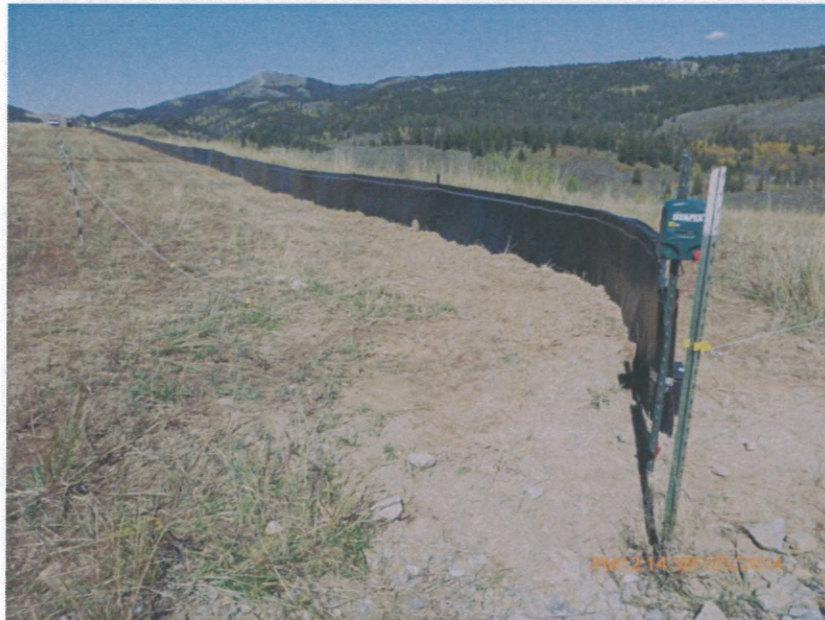
Photo No. 13 (P1000789)  
Facing north – electric fence outside of the silt fence being installed along the upper border of the vegetated side of the FMTE.

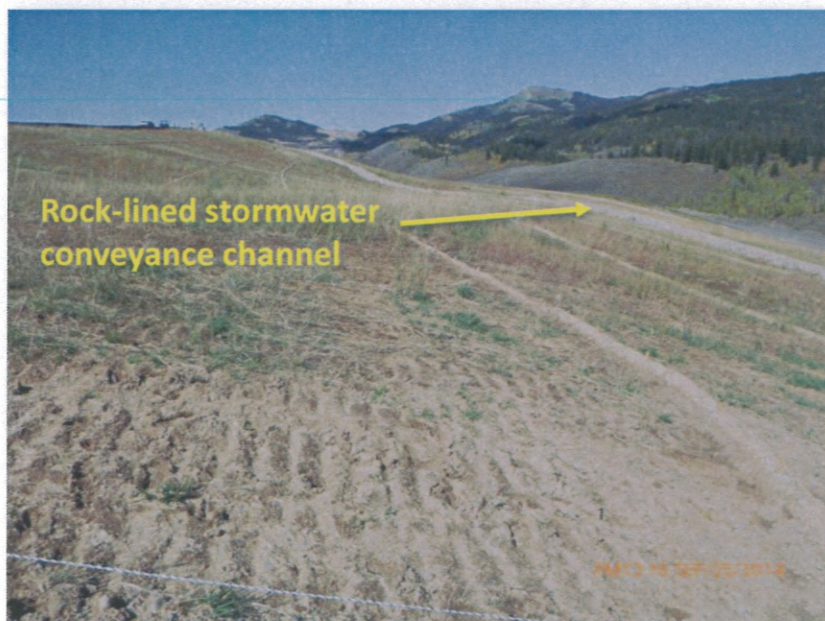
Photo No. 14 (P1000790)  
Facing north – track marks along the southern border of the boundary between the vegetated and the rock-armored cover suggest the possibility of recent erosion.

- Yes, significant erosion has occurred in 2013 and 2014 following the spring snowmelt and late summer thunderstorms on the soil cover portion of the FMTE. Repairs have been conducted during the 2013 and 2014 field seasons. The most recent significant erosion event occurred following the record-high precipitation event that occurred on August 23, 2014.

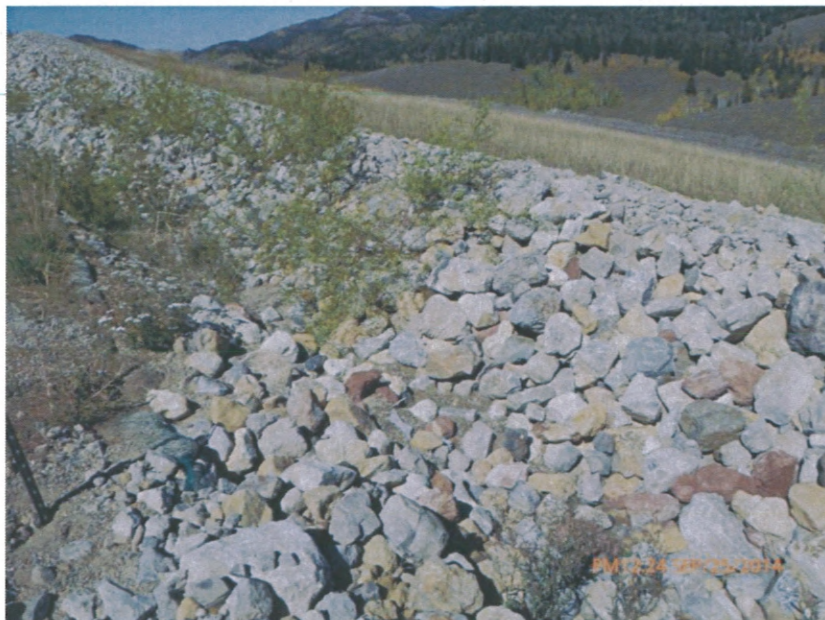
Photo No. 18 (P1000794)  
Facing northeast –the space between the rocks in the stormwater channel is filled with sediment in this section of the channel.

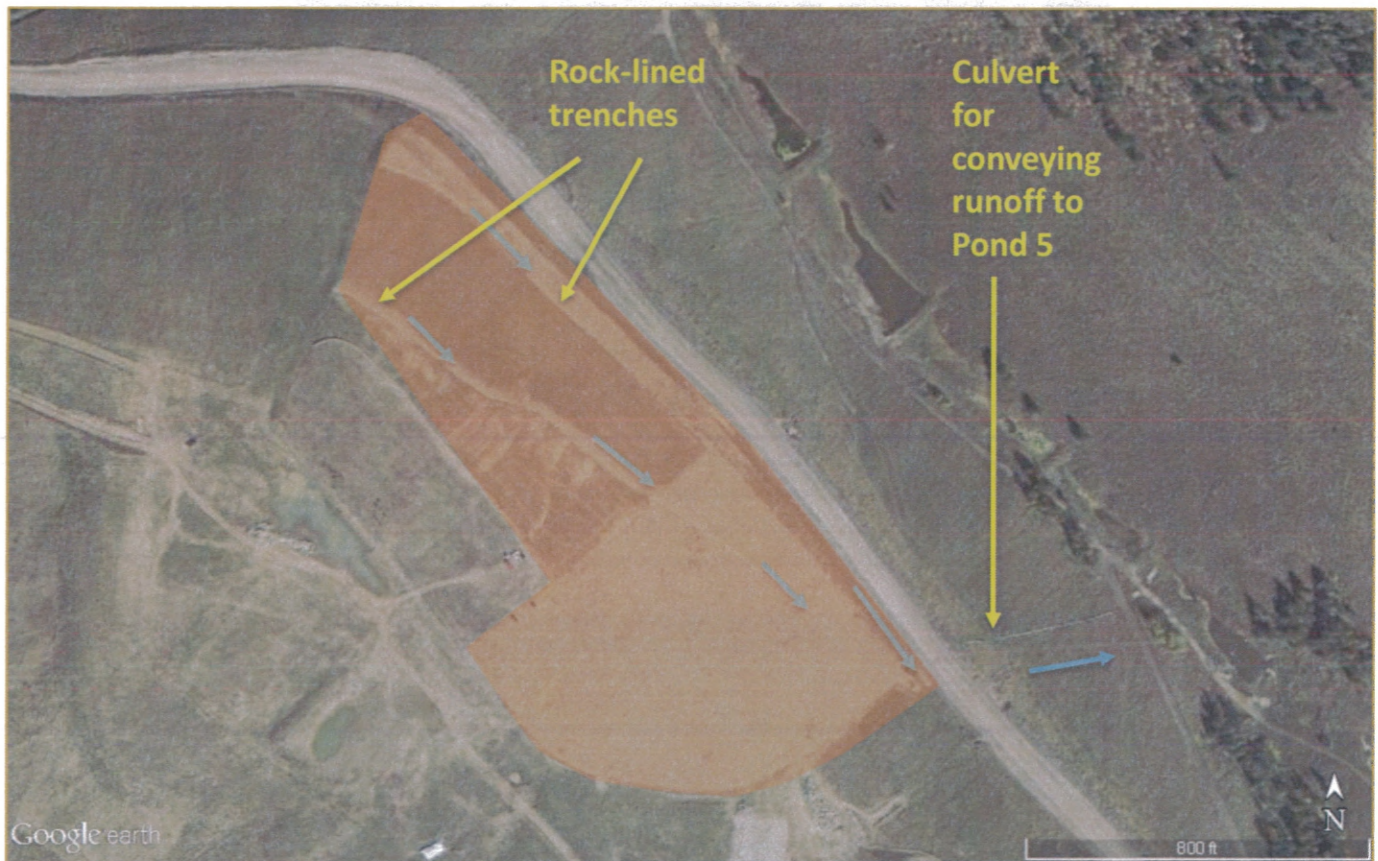
Photo No. 19 (Google Earth imagery date 10/7/2014)

South External Dump (SED) and Focused Mitigation Technology Evaluation (FMTE) cover system; note the rock-lined trenches for diverting runoff to Pond 5 in South Fork of Sheep Creek drainage.

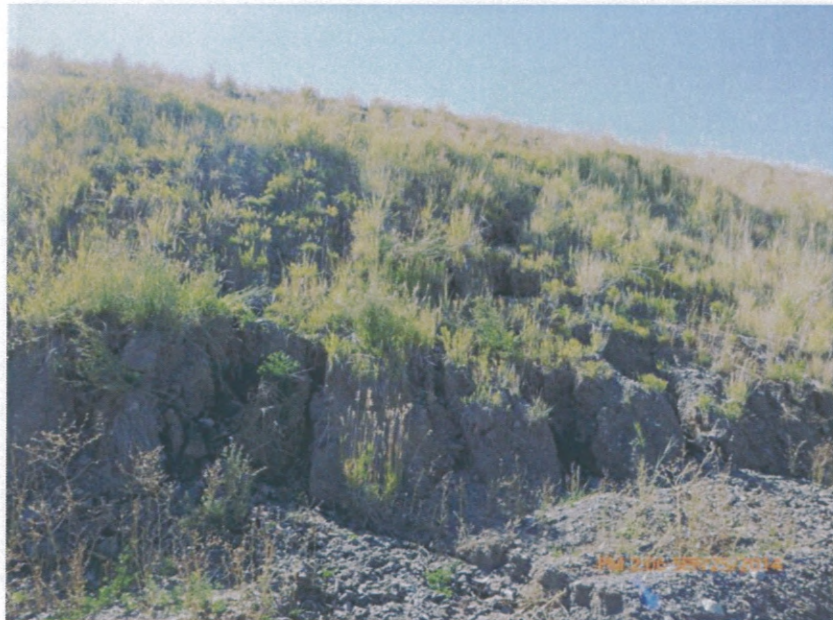
Photo No. 20 (P1000813)

Facing west – rill erosion near the base of the SED along the haul road

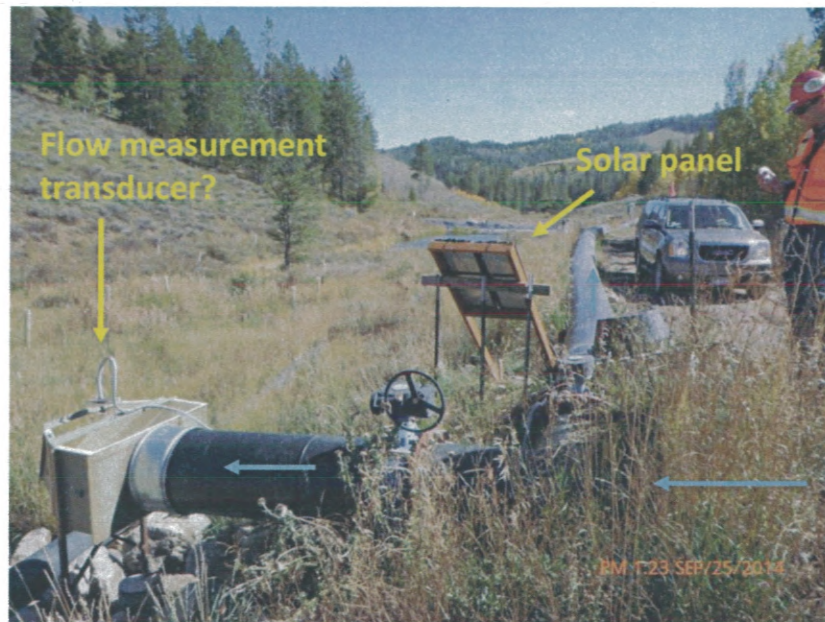
Photo No. 22 (P1000803)

**Note:** The piping and valve system for controlling the surface runoff discharge from the SED and the FMTE has some additional features worth noting. The outfall to Pond 5 appears to be equipped with a transducer for measuring flow. A solar energy panel is mounted nearby (as shown in Photo 22). These may be part of the data logger noted in *"Answers to the questions from Pat Stoll, EPA"* (see Attachment B). The valves for managing the direction of flow through the T-connector appear to have both an electric actuator and a manual control wheel.

Facing south— runoff from the FMTE cover system is discharged to the upper end of Pond 5 at this location. It would appear that water could potentially be diverted to the drainage below Pond 5, completely bypassing the pond in the process.

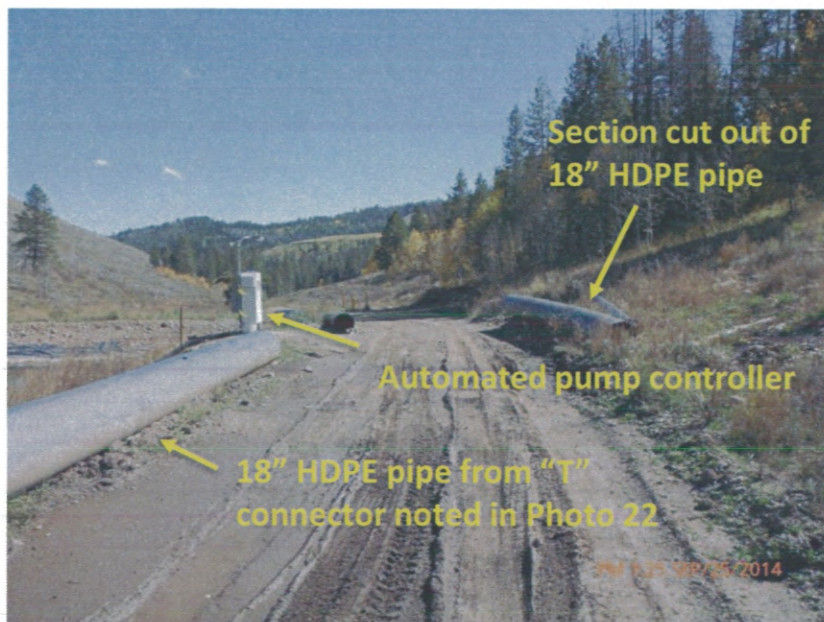
Photo No. 23 (P1000804)

Facing south – it appeared that a section of the 18" HDPE pipe had been removed from what appeared to be a bypass line; Nu-West staff could not explain the purpose of the line at the time of this inspection.

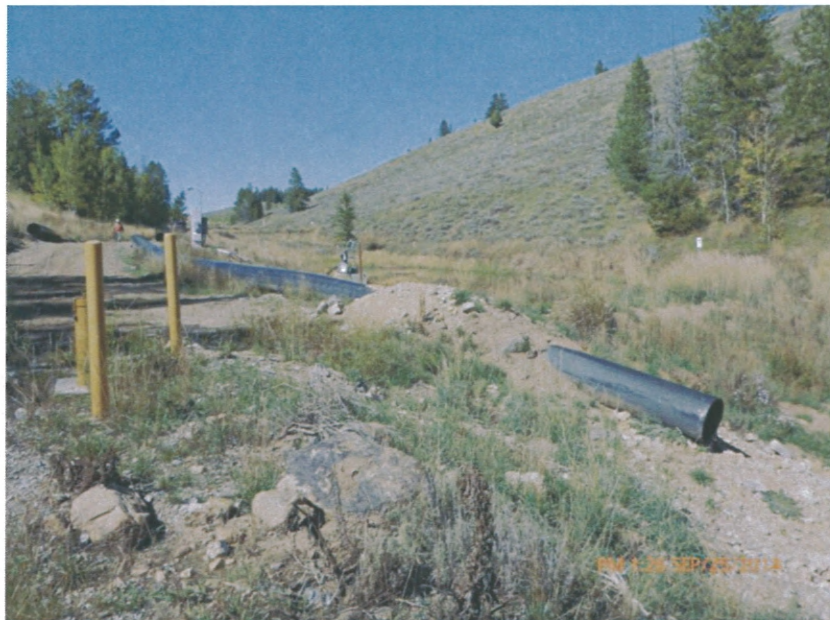
Photo No. 24 (P1000805)

Facing north – the 18" HDPE line noted in Photos 22 and 23 could discharge water to the drainage below Pond 5 if the section sitting along the road was re-installed.

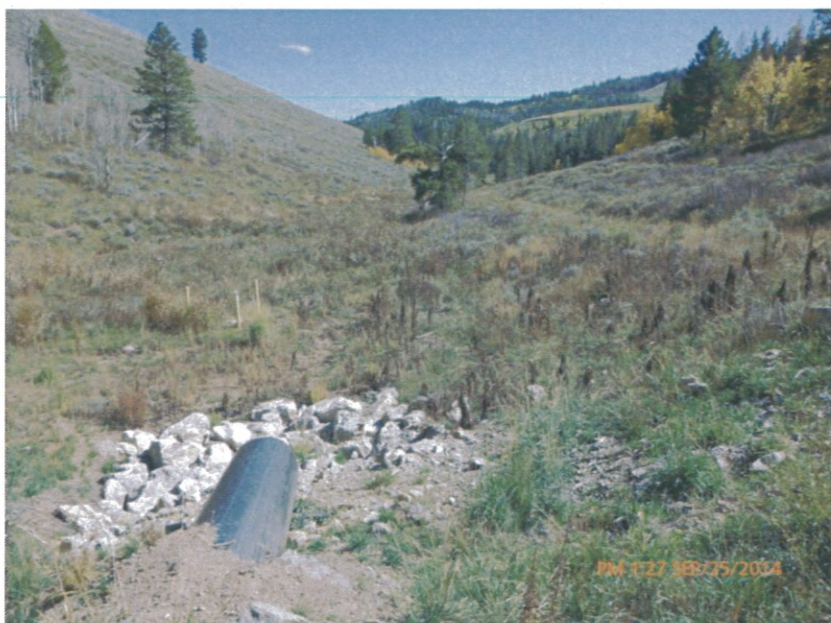
Photo No. 25 (P1000806)

Facing southeast – this is the location where the 18" HDPE could potentially discharge directly to the South Fork of Sheep Creek drainage, bypassing the water management ponds altogether.

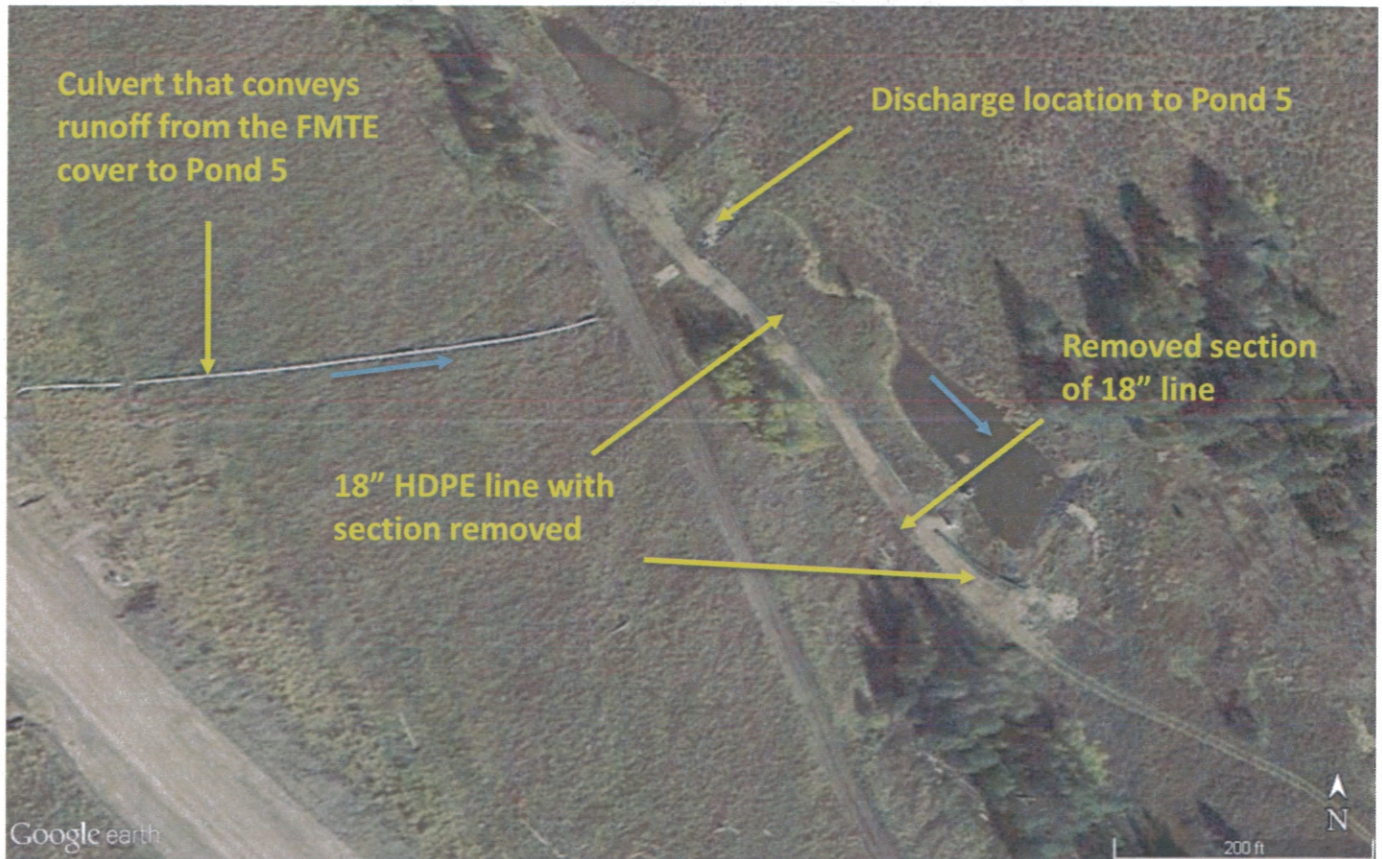
Photo No. 26 (Google Earth imagery date 10/7/2014)

This aerial photo shows the culvert that conveys runoff from the SED and the FMTE to the upper end of Pond 5. The 18" bypass line is visible in the photo.

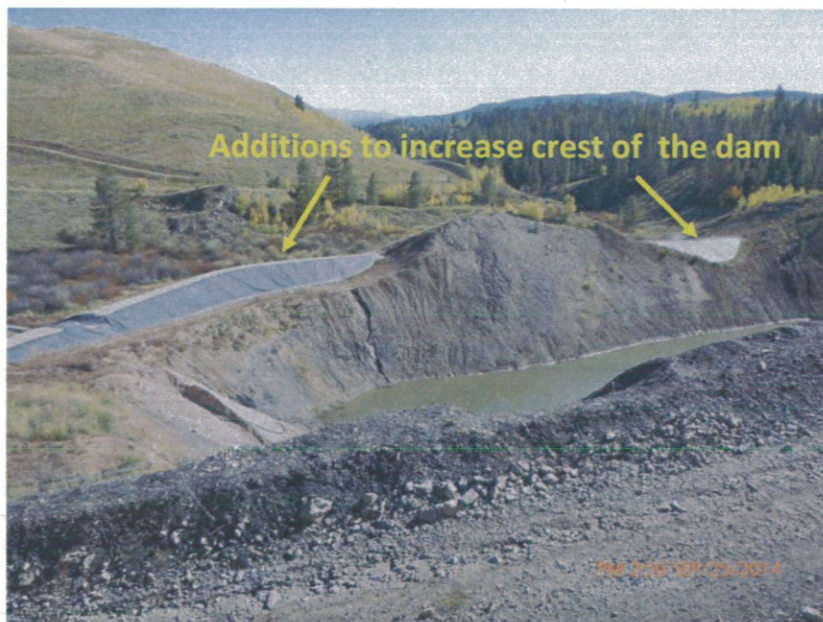
Photo No. 34 (P1000819)  
Facing south – this is the Central Pit Pond; note the two sections where the height of the dam has been increased to provide additional freeboard.
